UPPER GALLINAS CREEK RESTORATION OPPORTUNITIES

Gallinas Watershed Program

Investigating opportunities to restore the concrete channel in
Terra Linda to a natural channel

FINAL

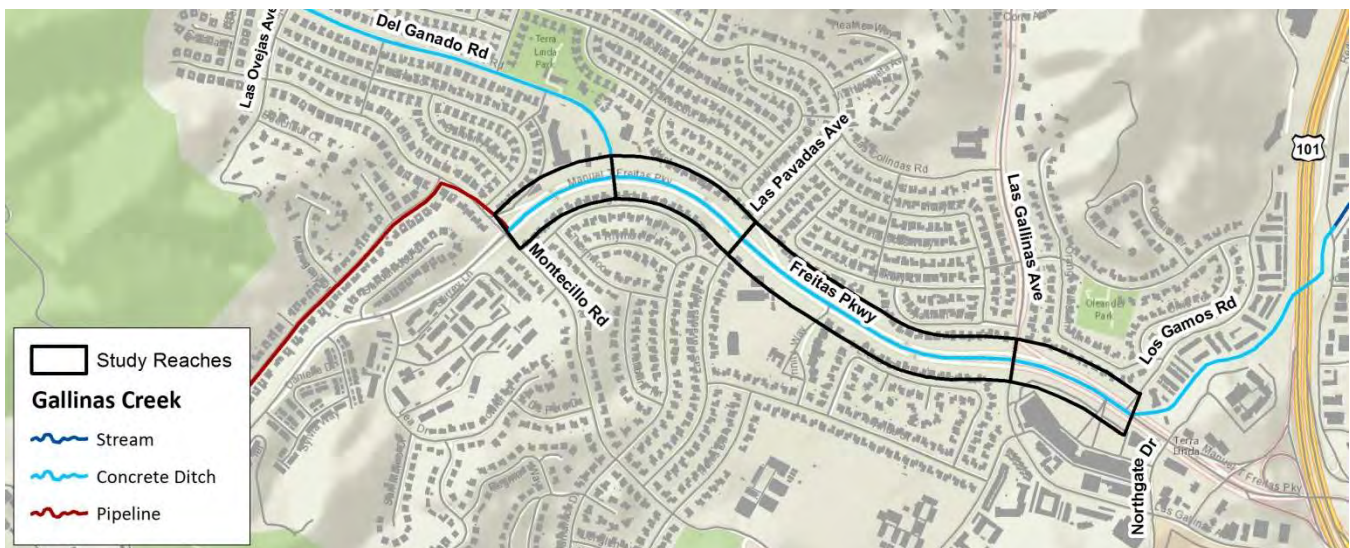
FIGURE 2: STUDY REACHES

This Restoration Opportunities Study focuses on the approximately 0.75-mile-long reach of the North Fork of Gallinas Creek along Freitas Parkway from Montecillo Road to Los Gamos Road (Figure 2). This reach flows in an open concrete-lined channel and has become perennial (flows all year) due to residential irrigation runoff and the non-permeable concrete channel bed. The concrete channel is not uniform throughout its length; therefore, this study considers four cross-sections in the following reaches:

- Monticello Road to Del Ganado Road
- Del Ganado Road to Las Pavadas
- Las Pavadas Avenue to Las Gallinas Avenue
- Las Gallinas Avenue to Los Gamos Road/Northgate Drive

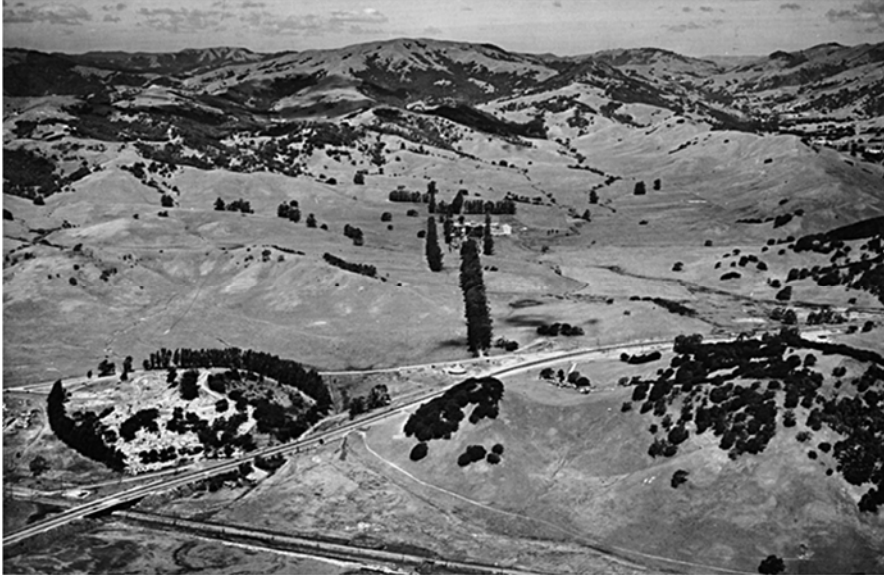
FIGURE 3: 1953 PHOTOGRAPH OF TERRA LINDA, COURTESY OF THE MARIN HISTORICAL SOCIETY

Figure 3 shows the watershed in 1953, prior to the major development that occurred in the post-war years. The creek corridor appears deeply incised and lacks extensive riparian vegetation - typical of creeks in highly grazed areas (KHE 2004).

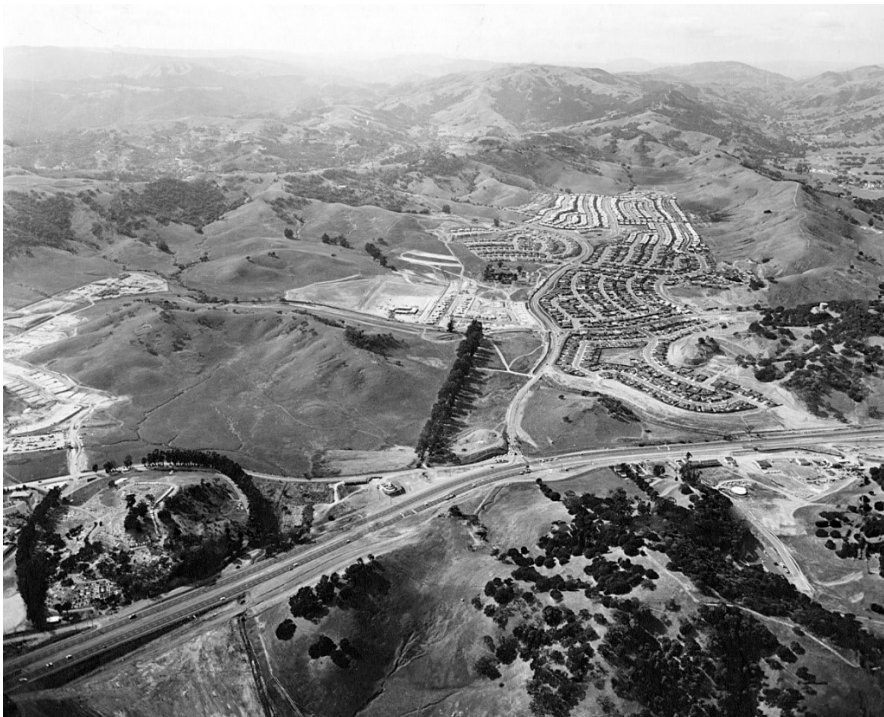
FIGURE 4: 1959 PHOTOGRAPH OF TERRA LINDA, COURTESY OF THE MARIN HISTORICAL SOCIETY

Development in the valley areas west of Highway 101 began around 1950, and the North Fork of Gallinas Creek and its tributaries were channelized along Del Ganado Road and Manuel T. Freitas Parkway, following the historic creek alignment. By 1959 (Figure 4), development within the valley floor had all but eliminated all signs of the natural vegetation.

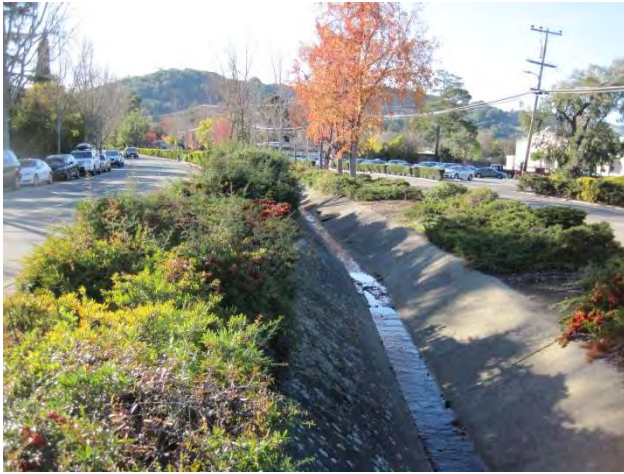
Figure 5: Monticello Road to Del Ganado Road

The Monticello Road subreach is the steepest and the furthest upstream subreach in the study area. The creek channel is 16 feet wide, concrete-lined, and flows within a 38-foot right-of-way. A typical cross-section of the creek and parkway is shown in Figure 5. A photo of the subreach is included in Figure 9.

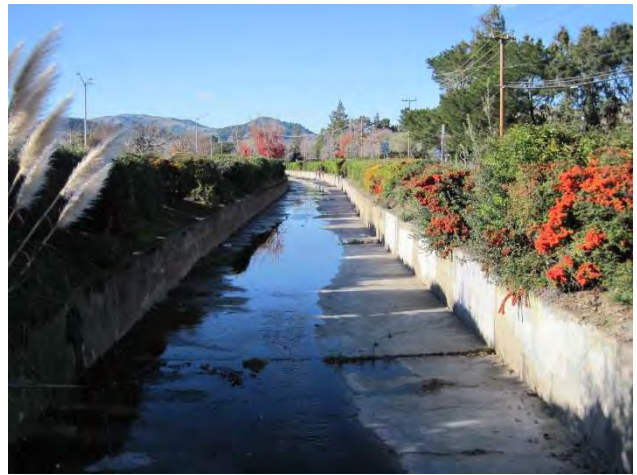
Figure 8: Las Gallinas to Northgate Drive

The Las Gallinas Avenue subreach is the downstream-most subreach in the study area. The creek channel is 25 feet wide, concrete-lined, and flows within a 48-foot right-of-way. A typical cross-section of the creek and parkway is shown in Figure 8. A photo of the subreach is included in Figure 9.
